# ES\_LPC18S50/S30/S10

## Errata sheet LPC18S50, LPC18S30, LPC18S10

Rev. 1.8 — 25 September 2019

Errata sheet

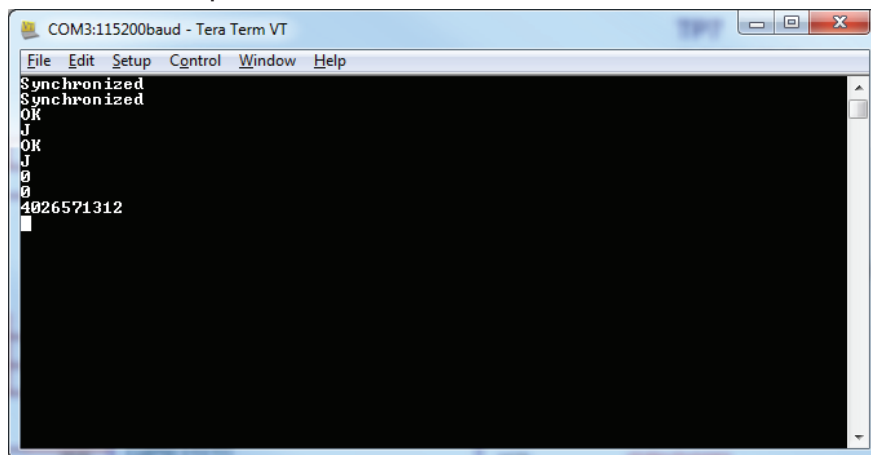
Incorrect example:

The 'J' command in ISP mode should return an error code, followed by an ASCII string representation of the part ID, followed by a 0. However what is actually returned is the error code, followed by a 0, followed by an ASCII string representation of the part ID. The problem is the last two items returned are swapped.

There is no work-around for this problem.

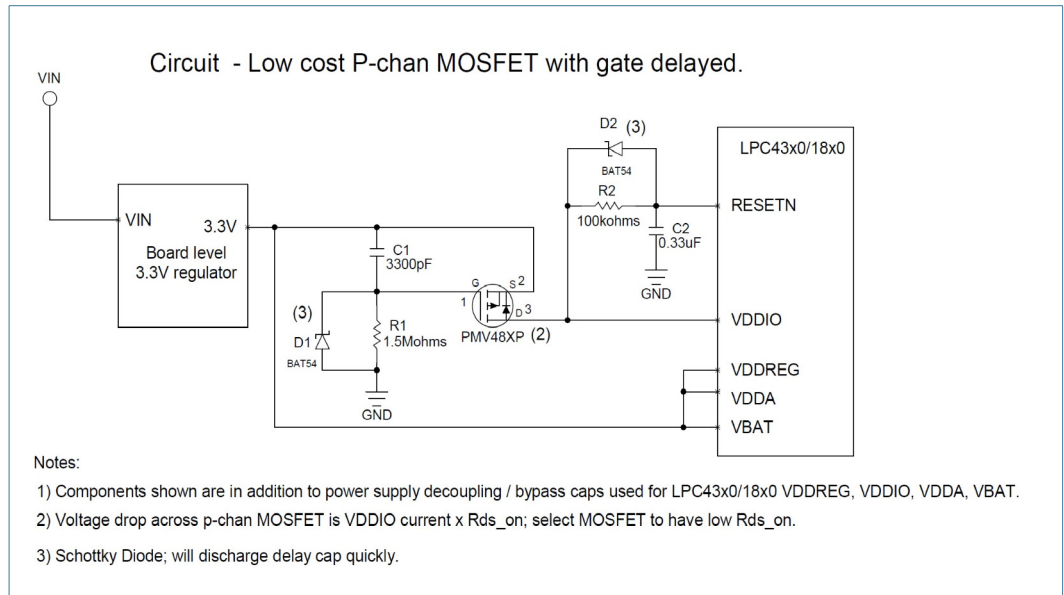
On all packages, repeated power cycling of the device may cause erroneous programming of the OTP banks. During ramp-up, the VDDREG supply voltage does not have enough time to settle and initialize the OTP controller before valid programming voltage is reached on the VPP pin. This may cause accidental programming of the OTP banks. Accidental programming of the OTP banks does not occur during Power-down of the supply voltage.

- Do not tie VDDIO to VDDREG and VDDA pins. The power supplied to the VDDIO pin should be delayed by 2 ms after the power supply on the VDDREG and VDDA pins stabilizes at the operating voltage level. The signal to the RESETN pin must also be delayed by 2 ms after the power supply on the VDDIO pin stabilizes at the operating voltage level.

The following circuit diagram is an example that shows the P-channel MOSFET with the gate delayed and the R-C delay circuit connected to the RESETN pin.

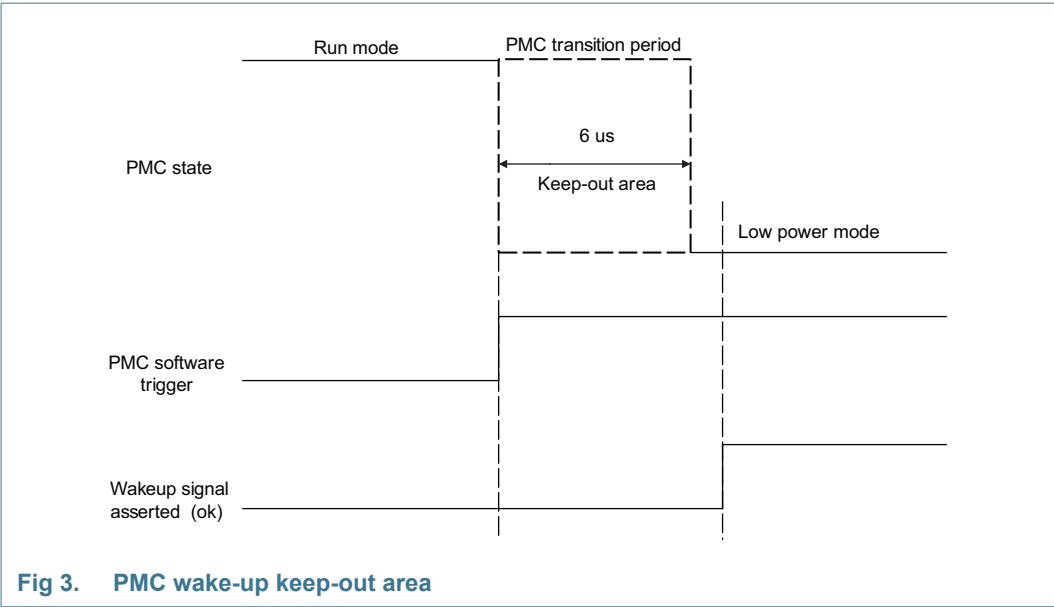
Fig 3. PMC wake-up keep-out area

When the chip is in a transition from active to Deep Sleep, Power Down, or Deep Power Down, wake-up events are not captured and they will block further wake-up events from propagating. The time window for this transition is 6  $\mu$ S and is not affected by the chip clock speed. After a wake-up event is received during the PMC transition, the chip can only recover by using an external hardware reset or by cycling power.

Make sure that a wake-up signal is not received during the Deep Sleep, Power Down, or Deep Power Down transition period. An example circuit to work around this could include an external 6  $\mu$ S one shot which could be triggered via software using a GPIO line when entering Deep Sleep, Power Down, or Deep Power Down mode. The one-shot's output could be used to gate the wake-up signal(s) to prevent receiving a wake-up signal during the PMC transition period. Depending on the system design, it may also be needed to latch the wake-up signal(s) so that they will still be present after the one-shot's 6  $\mu$ S time-out.

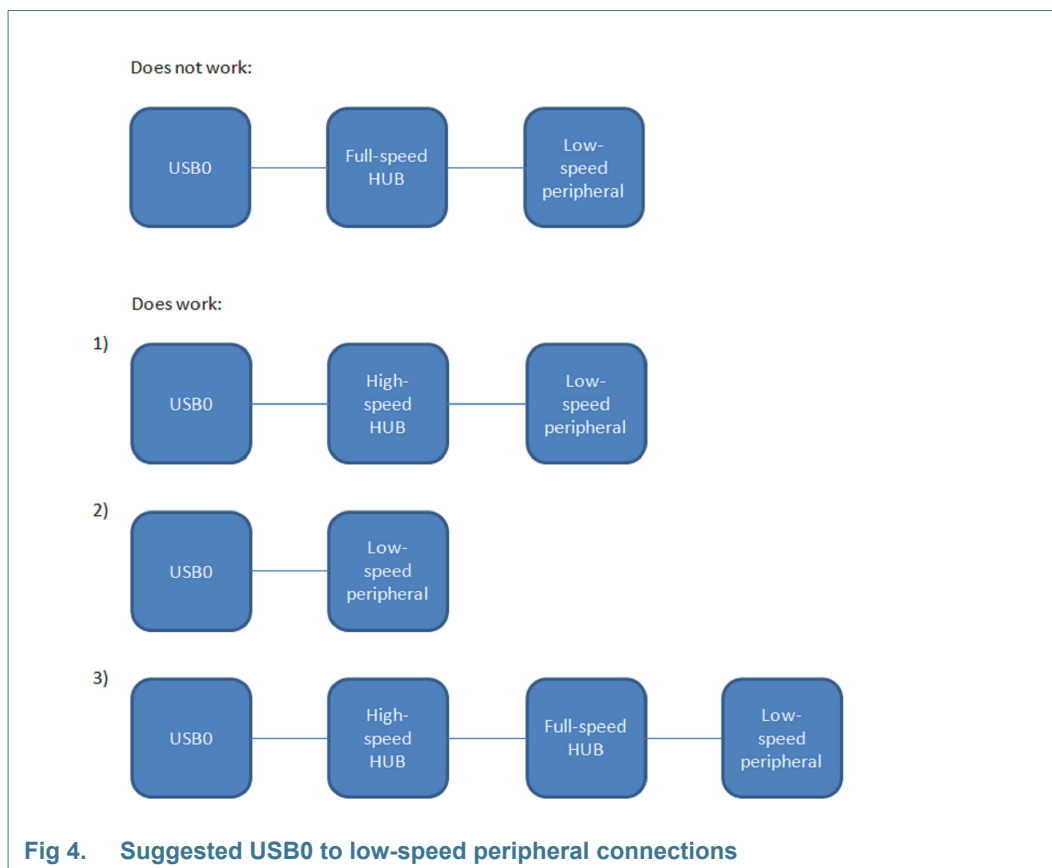
The USB controller called USB0 is unable to communicate with a low-speed USB peripheral in host mode when there is a full-speed hub directly connected to the USB0 port and a low-speed peripheral is connected in the tree somewhere below this full-speed hub. Only USB0 has this problem; the other USB controller, USB1 does not.

There is no work-around for this problem. It is suggested that the low-speed USB peripheral is either connected directly to USB0 or a high-speed hub is placed between that peripheral and USB0.
